JANUARY 15, 2019

# BUILDING DEFECTS REPORT

SP2651: 1 SAMPLE ROAD, EXAMPLE NSW 2035

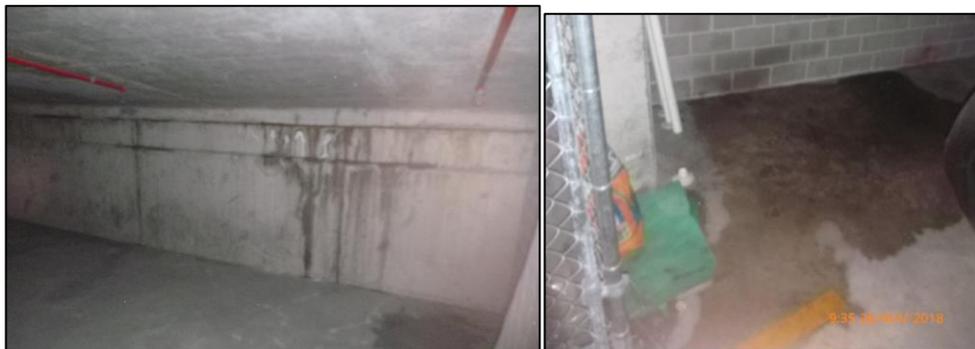
### 4.1.3 Photos

<b>Defect</b>	Uncontrolled water seepage from the base of the block wall at the junction with the slab. Seepage ranged from minor presence of water to considerable pooling on the carpark slab. In some areas the observed seepage was flooding storage cages.
<b>Breach</b>	<p><b>Home Building Act (HBA) (NSW) 1989</b> Part 2C, 18B (a) and (c).</p> <p><b>National Construction Code (NCC) 2103 – Volume 3 – Plumbing Code of Australia</b> <b>Part D2 Surface and Subsurface Drainage Systems</b> <i>DP2.1 Surface Drainage Systems</i> Surface drainage systems must dispose of stormwater flows from rainfall events having an average recurrence interval appropriate to the importance of the site and the severity of potential damage to property, loss of amenity, illness or injury that would result from the failure of such a system.</p> <p><i>DP2.3 Surface drainage installation</i></p> <ul style="list-style-type: none"> <li>(j) avoid the likelihood of loss to buildings or property; and</li> <li>(k) avoid the likelihood of uncontrolled discharge</li> </ul> <p><b>Loss Suffered</b> The owners of the storage affected storage cages are suffering a loss as the water is causing damage to the stored personal property.</p> <p>Additionally, the presence of excessive water in basement areas may be a health concern as it can remain stagnant for extended periods of time.</p>

Further investigation required to determine the source of water ingress.

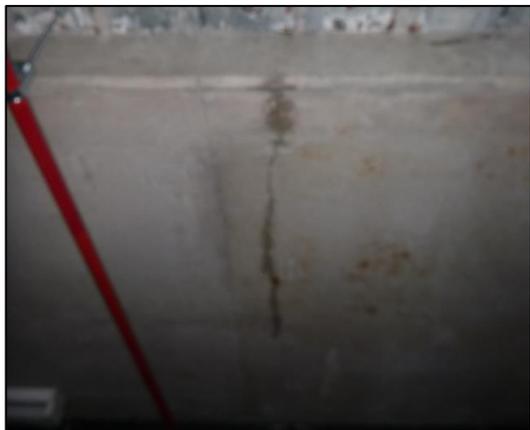
### 4.2.3 Photos

<b>Defect</b>	Uncontrolled water seepage from the base of the block wall at the junction with the slab. Seepage ranged from minor presence of water to considerable pooling on the carpark slab. In some areas the observed seepage was flooding storage cages.
<b>Breach</b>	<p><b>Home Building Act (HBA) (NSW) 1989</b> Part 2C, 18B (a) and (c).</p> <p><b>National Construction Code (NCC) 2103 – Volume 3 – Plumbing Code of Australia</b> <b>Part D2 Surface and Subsurface Drainage Systems</b> <i>DP2.1 Surface Drainage Systems</i> Surface drainage systems must dispose of stormwater flows from rainfall events having an average recurrence interval appropriate to the importance of the site and the severity of potential damage to property, loss of amenity, illness or injury that would result from the failure of such a system.</p> <p><i>DP2.3 Surface drainage installation</i></p> <ul style="list-style-type: none"> <li>(j) avoid the likelihood of loss to buildings or property; and</li> <li>(k) avoid the likelihood of uncontrolled discharge</li> </ul> <p><b>Loss Suffered</b> The owners of the storage affected storage cages are suffering a loss as the water is causing damage to the stored personal property.</p> <p>Additionally, the presence of excessive water in basement areas may be a health concern as it can remain stagnant for extended periods of time.</p>

Further investigation required to determine the source of water ingress.

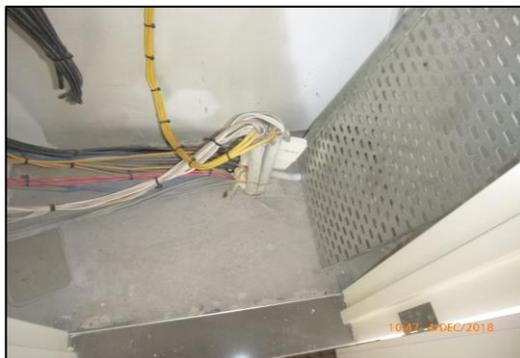
### 4.3.3 Photos

<b>Defect</b>	<p>During the inspections it was noted that all penetrations through the slabs for the provision of services have not been completed in a manner that is considered fire-resistant. In all communications and electrical cupboards, it was observed that penetrations through the slab had been sealed without the use of fire pillows and only with an expanding foam. The manner in which it has been completed leaves voids through the penetrations and will allow for the spread of fire between levels. It is unknown whether the installed expanding foam is fire rated.</p> <p>It was also observed that in various areas where service penetrations are present, there is unused conduits penetrating the slab which have not had any fire-resistant finishing applied.</p>
<b>Breach</b>	<p><b>Home Building Act (NSW) 1989</b></p> <ul style="list-style-type: none"> <li>• Part 2C, 18B (a), (B) and (c).</li> </ul> <p><b>National Construction Code (NCC) 2013 – Volume 1 – Class 2-9 Buildings</b></p> <ul style="list-style-type: none"> <li>• Section C Fire Resistance             <ul style="list-style-type: none"> <li>○ Part CO1                 <ul style="list-style-type: none"> <li>▪ Performance Requirements CF2 &amp; CP8.</li> </ul> </li> </ul> </li> </ul> <p>This is a breach of the BCA as it requires suitable fire-resistant elements to prevent spread of fire between separate levels.</p> <p><b>Loss Suffered</b> Loss suffered is the cost of rectification.</p>

Engage a suitably qualified fire engineer to assess the defects and provided a detailed rectification procedure.
